Antriebsriemen & Kits

Technische Information für die Werkstatt

Ausgabe 76 | Dezember 2025

ERGÄNZENDER EINBAUHINWEIS

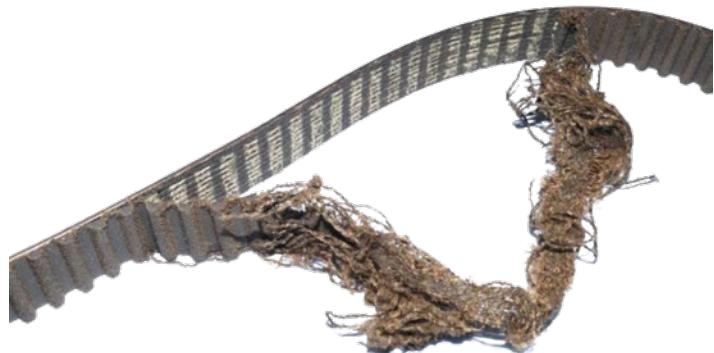
Bei diesen Motoren kann es durch eine falsche Einstellung der Kraftstoff-Hochdruckpumpe zu einem Überschreiten der Belastungsspitzen im Riementriebs kommen.

- Stark verschlissene oder fehlende Zähne in einem begrenzten Bereich des Zahnriemens.
- Ein verschobenes oder loses Flügelrad in der Wasserpumpe.

Die Spitzenbelastungen durch die Nockenwelle und die Hochdruckpumpe (HDP) sind nicht gleichmäßig verteilt, sondern auf einen Punkt konzentriert. Durch die dadurch entstehenden pulsierenden Lastspitzen werden einige Zähne des Riemens zerrieben und der Presssitz des WP-Flügelrades auf der Welle gelöst.

Bosch empfiehlt, unbedingt nach Abschluss der Arbeiten am Steuertrieb die Position der HDP zu prüfen und nach Angaben des Fahrzeugherstellers zu korrigieren.

- **Markierung am HDP-Antrieb fluchtet mit der Markierung am Gehäuse.**
- **Nockenwellenriemenscheibe ist abgesteckt auf HDP-Einbauposition (nicht OT).**

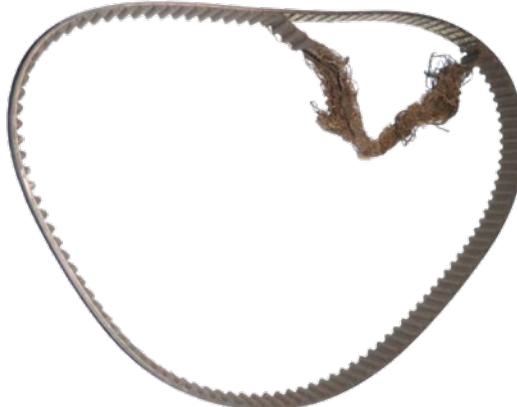
Je größer die Abweichung der HDP-Einstellung von der korrekten Position, desto früher kommt es zum Schaden und Ausfall des Riementriebs.

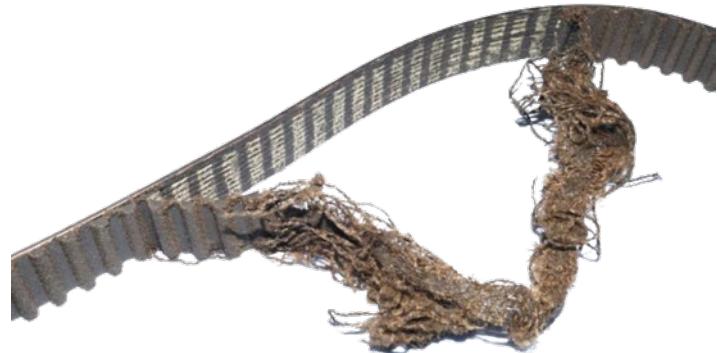
In these engines, incorrect adjustment of the high-pressure fuel pump can cause the load peaks in the belt drive to be exceeded.

- Heavily worn or missing teeth in a limited area of the timing belt.
- A displaced or loose impeller in the water pump.

The peak loads from the camshaft and the high-pressure pump are not evenly distributed, but concentrated at a single point. The resulting pulsating load peaks cause some of the belt teeth to be worn down and the press fit of the WP vane wheel on the shaft to be loosened.

Bosch recommends always checking the position of the HDP after completing work on the timing drive and correcting it according to the vehicle manufacturer's specifications.

- The mark on the HDP drive is aligned with the mark on the housing.
- The camshaft pulley is pinned to the HDP installation position (not TDC).

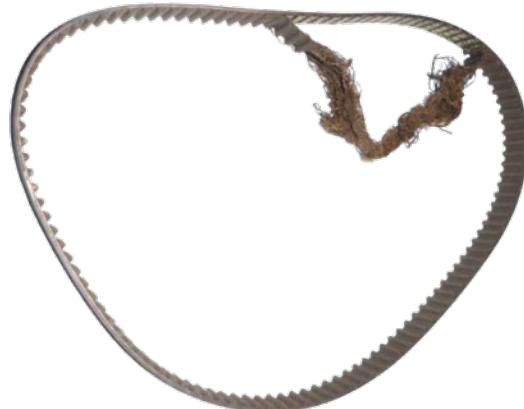
The greater the deviation of the HDP setting from the correct position, the sooner damage and failure of the belt drive will occur.
